# Technical Research Bulletin

VOLUME 6 2012

# The fall and rise of a Roman statue: the Kew Gardens Hermes

KATHRYN OLIVER, PETER HIGGS AND MICHELA SPATARO

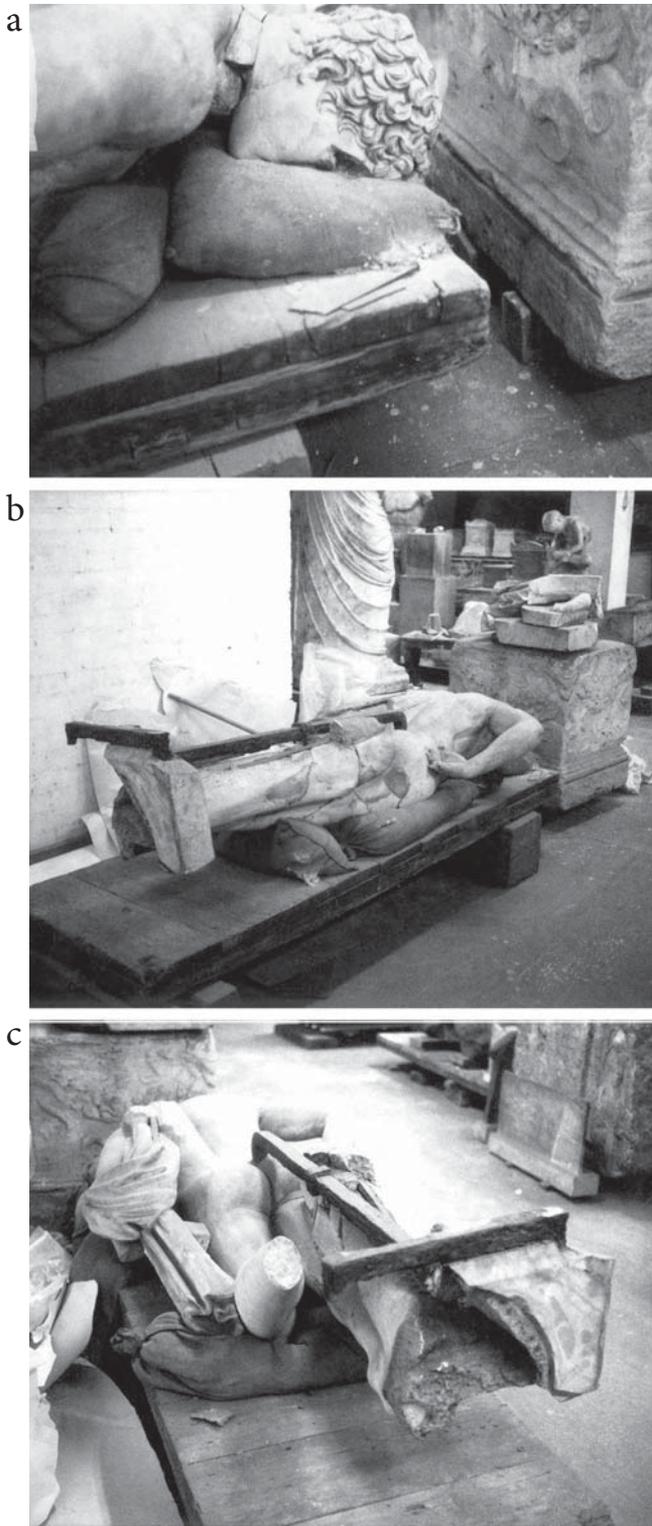
FIGURE 1. The Kew Garden Hermes: three photographs of the sculpture taken in 1976. Images: courtesy of Royal Botanic Gardens, Kew

halt at some stage and unfortunately there are no written records documenting their interventions. The images in Figure 1, which accompanied Brian Cook's letter to Kew in 1976, are therefore particularly helpful in understanding the sculpture's more recent history and its likely condition on arrival at the BM. From these photographs the sculpture appears to have remained deceptively intact, with just the plinth broken into four sections. One section of the plinth remained attached to the figure, the other three sat on top of an ancient altar close to the statue's head, Figures 1a and 1b.<sup>2</sup> It would be unusual for the plinth of a large sculpture to break without the statue sustaining damage. This posed a number of questions: how much further, unseen, damage had occurred; exactly how far had the stonemasons progressed with their work; and how would this affect the future reassembly of the pieces?

It was clear that since the photographs in Figure 1 were taken, the stonemasons had carried out extensive work as part of the second main restoration. In these images a large iron cramp can be seen that ran from a hole in the back of the torso, down the tree stump, to the plinth where it divided to form a 'T-bar', Figures 1b and 1c. In Figure 1b a second, smaller cramp can be seen in the tree stump beneath the main cramp. The stonemasons had obviously removed both cramps, leaving staining from the corroded iron. Although, in the images, only one cramp can be seen on the back of the tree stump, the loss of stone in this area is quite extensive, perhaps because the bottom of the cramp had been fitted so deeply that the hole made for it joined with the central dowel hole. At the top of the cramp there are also three circular holes with diameters of 22 and 29 mm, the reason for which is no longer clear. The considerable losses of stone around the cramps seen in Figure 1 would have reduced the support offered by the tree stump and although it would undoubtedly still provide enough strength to the right leg when the figure was standing, when the sculpture was exposed to unusual

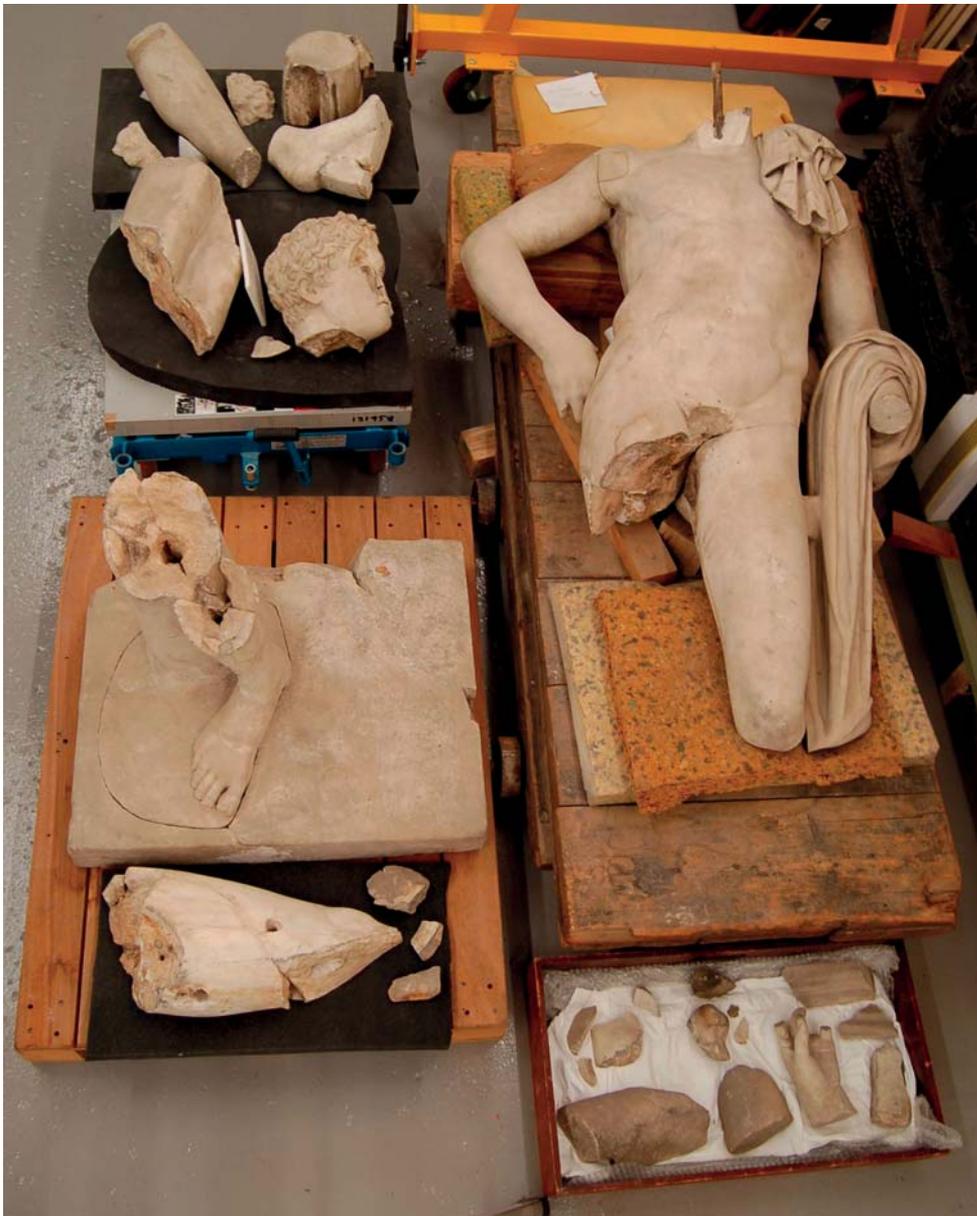
FIGURE 2. The collapsed sculpture on its arrival in the stone, wall paintings and mosaics conservation studio in 2009

Many of the parts of the sculpture that had been bonded as part of the first restoration were dismantled in the second, leaving just the arms and left thigh attached, Figure 2. Any dowels within the right leg had been removed and, although these areas are now covered in extensive surface dirt, none of the binding material used to hold the dowels remained.

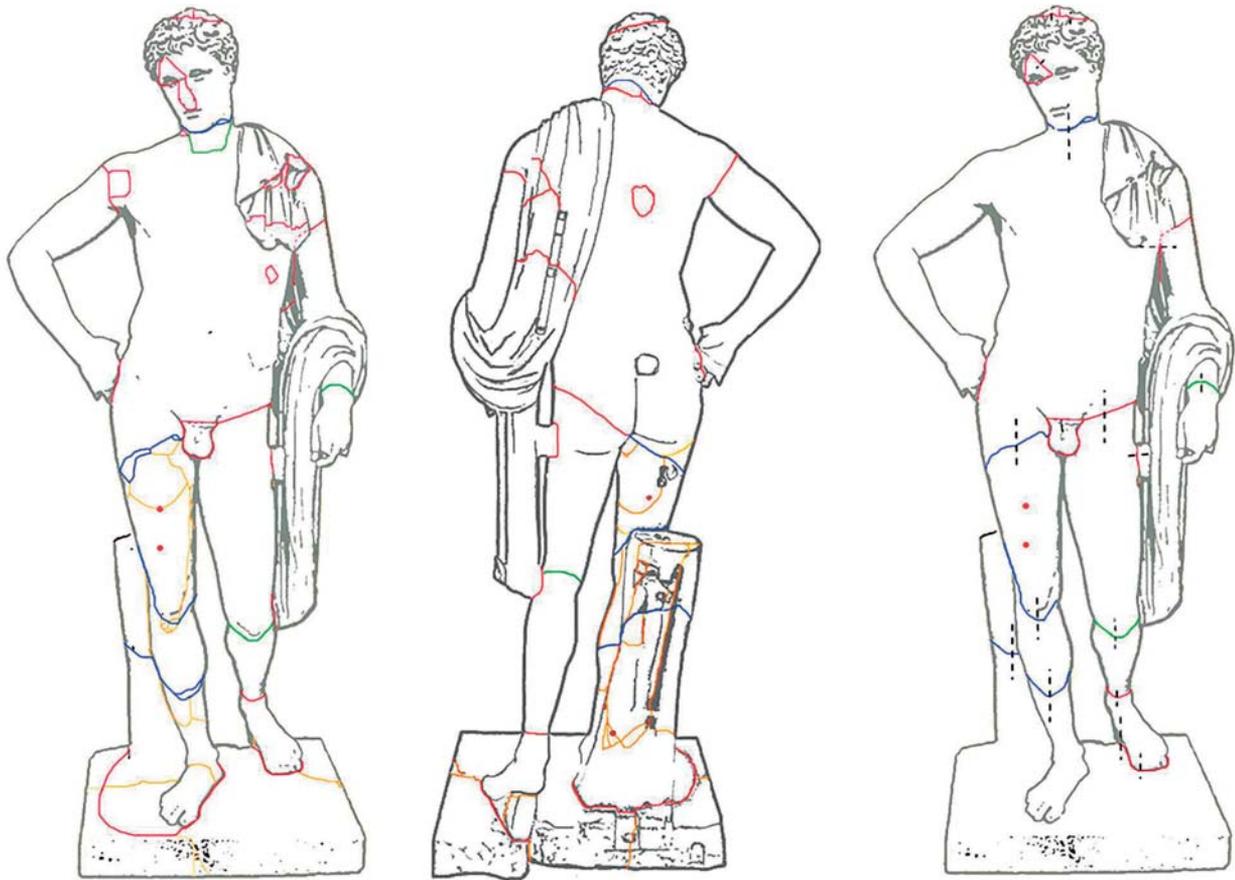
FIGURE 3. Diagrammatic representation of the phases of restoration: the blue lines represent ancient breaks that were adjusted, dowelled and bonded in the first restoration; the red lines indicate reworked surfaces and replicated pieces fitted in the first restoration; the yellow lines show breaks bonded by the stonemasons during the second restoration; the green lines indicate breaks that had not previously been bonded; and the black dashed lines show the locations of dowels and pins. Drawing (not to scale): Kathryn Oliver

The base had been bonded together using what is believed to be a mastic adhesive and a large area of the underside was covered with plaster of Paris, masking some of this work. The main focus of the second restoration had been the right leg and tree stump, which had been reassembled from 35 smaller fragments and bonded with mastic. Figure 3 shows the various joins and phases of restoration diagrammatically.

The main damage to the sculpture after the first restoration was centred on the proper right leg, tree stump and plinth, which were broken into at least 39 fragments,

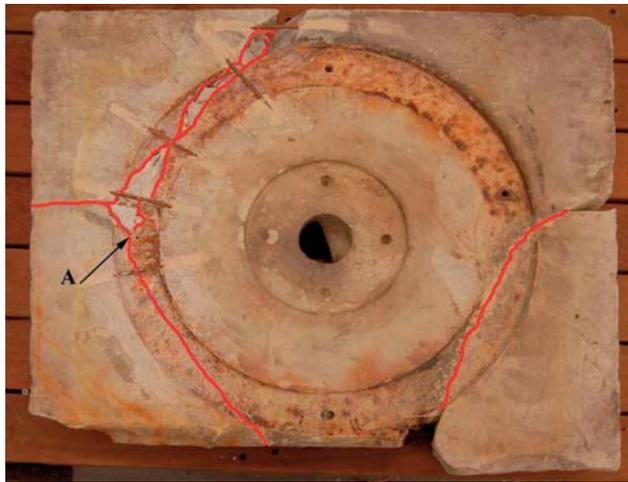
FIGURE 4. The underside of the plinth showing the recess carved to receive an iron turntable. The red lines indicate the joints that were bonded during the second restoration in the 1970s. The point 'A' beneath the right foot and tree stump at which three of these breaks meet is indicated by an arrow

depth of the stone beneath the original elements to 15 mm and, unsurprisingly, it is here that the three main breaks to the plinth all meet, point A on Figure 4. One theory is that as the turntable corroded – evident from the extensive staining and fragments of highly corroded friable iron – the thin layer of stone beneath the load-bearing right leg was left unsupported and the plinth cracked and eventually broke. The large iron T-bar bracing the plinth across one of these breaks suggests that a crack may have been present for some time, although as no attempt had been made to brace the side or front, these breaks may have developed later. It seems likely that as the base broke the weight of the sculpture caused it to become unstable until the proper right leg and tree stump dropped as the base separated.

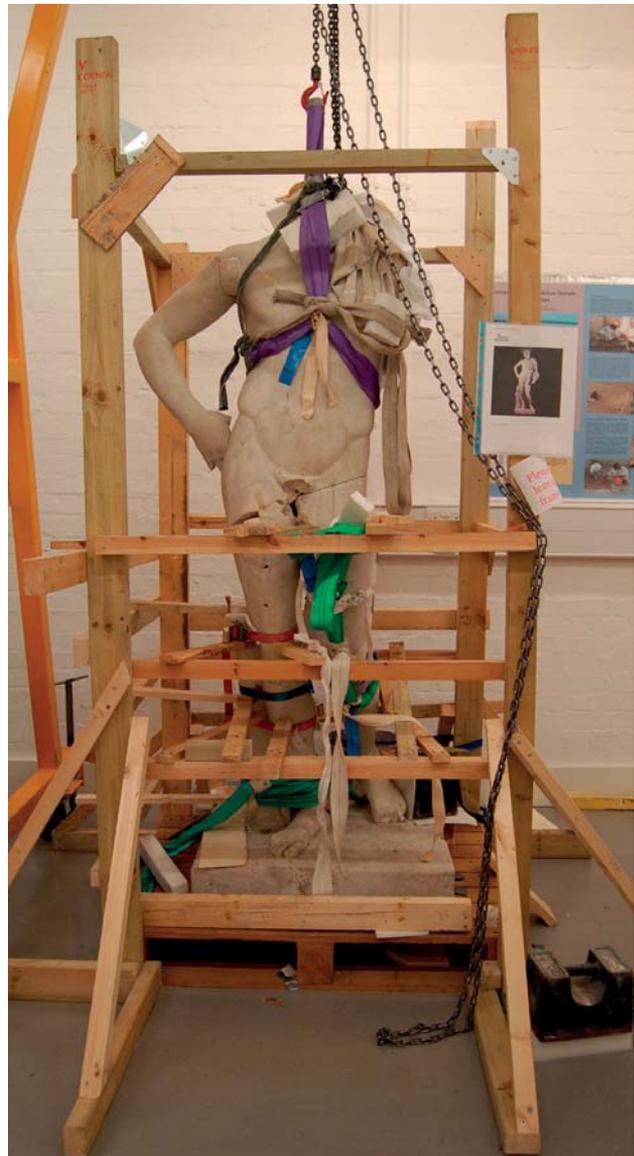
FIGURE 5. The sculpture dry built within the wooden frame during the course of the conservation treatment

A system was devised that would allow the repeated assembly and disassembly of the fragments without adhesive (i.e. dry built). A wooden frame was constructed that provided support to each fragment, allowing precise, individual adjustments to be made without hindering examination of the statue as work progressed, Figure 5. The framework structure began as a simple 'cube' with stabilizing braces running to the ground at each corner. From this basic structure, battens could be added that protruded inwards to hold the fragments in place. One side of the framework was detachable to allow any sections of the statue slung from the overhead gantry to be positioned without compromising the strength and support required for those already in position.

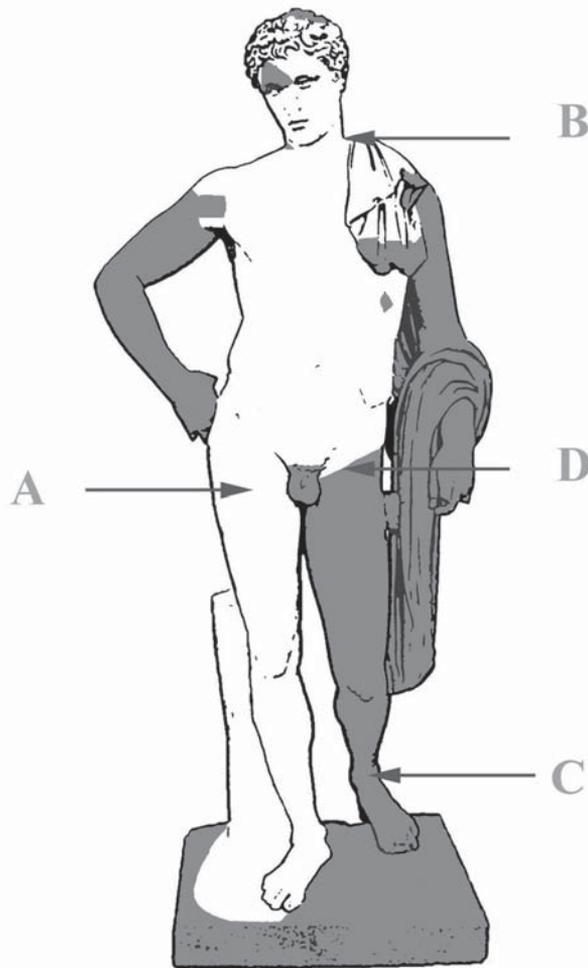
FIGURE 6. Diagrammatic representation of the sections of the sculpture that are original Roman marble (shown in white) or that were carved and attached as part of the first restoration (shown shaded grey). The arrows and labels indicate the locations from which the samples for stone analysis were taken. Drawing: Kathryn Oliver

As outlined above, scientific analysis of some parts of the statue was undertaken where the nature of the earlier restoration led to doubt about which parts of the statue were original and which restored. Using a small chisel, four samples less than 1 cm<sup>3</sup> in size were taken in unobtrusive areas, to avoid visible damage. They were taken from the join surface at the top of the right thigh (sample A), from the break surface at the neck of the torso (sample B), from the left foot, adjacent to the ankle dowel hole (sample C) and from the dowel hole in the left thigh (sample D), Figure 6.

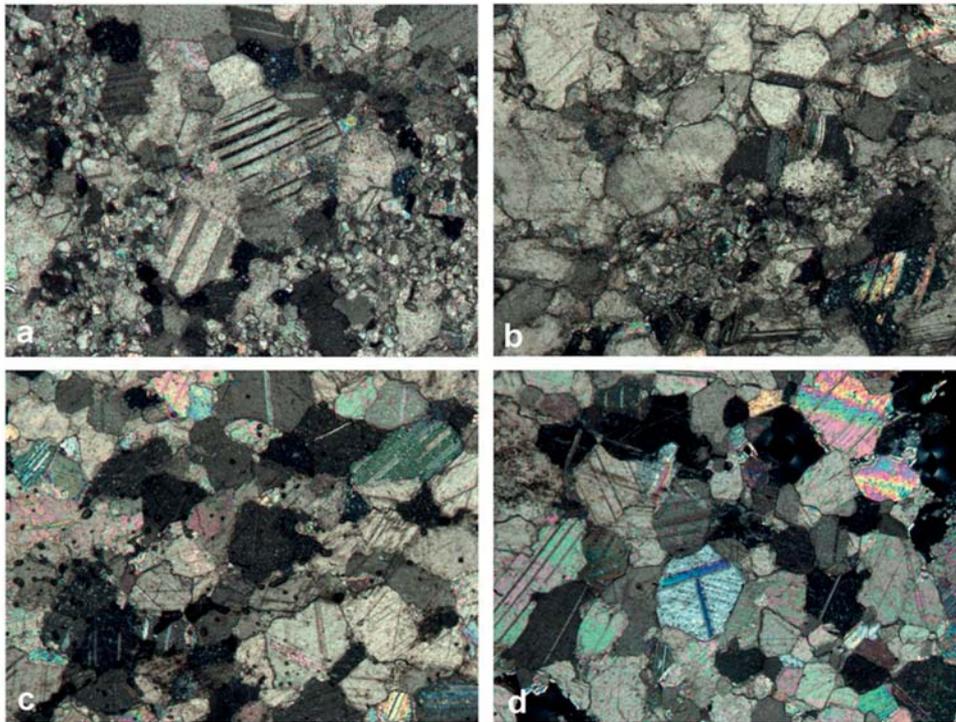
In the thin-section, samples A and B are very similar; they exhibit polygonal large calcite crystals of similar sizes (up to 0.3 × 0.3 mm) and a heteroblastic texture with layers and lenses of fine-grained dolomite within a groundmass of coarse-grained calcite with recrystallization at the calcite grain boundaries, Figures 7a and 7b.

Samples C and D are similar; they have a groundmass of coarse-grained calcite crystals (0.2 × 0.2 mm) that show bright colours typical of the high birefringence of calcite under cross-polarized light, occasional muscovite and no dolomite, Figures 7c and 7d.

FIGURE 7. Photomicrographs of thin-sections made from the four stone samples, viewed under cross-polarized light: (a) dolomitic marble sample A; (b) dolomitic marble sample B; (c) calcitic marble sample C; and (d) calcitic marble sample D. Field of view 1.74 mm

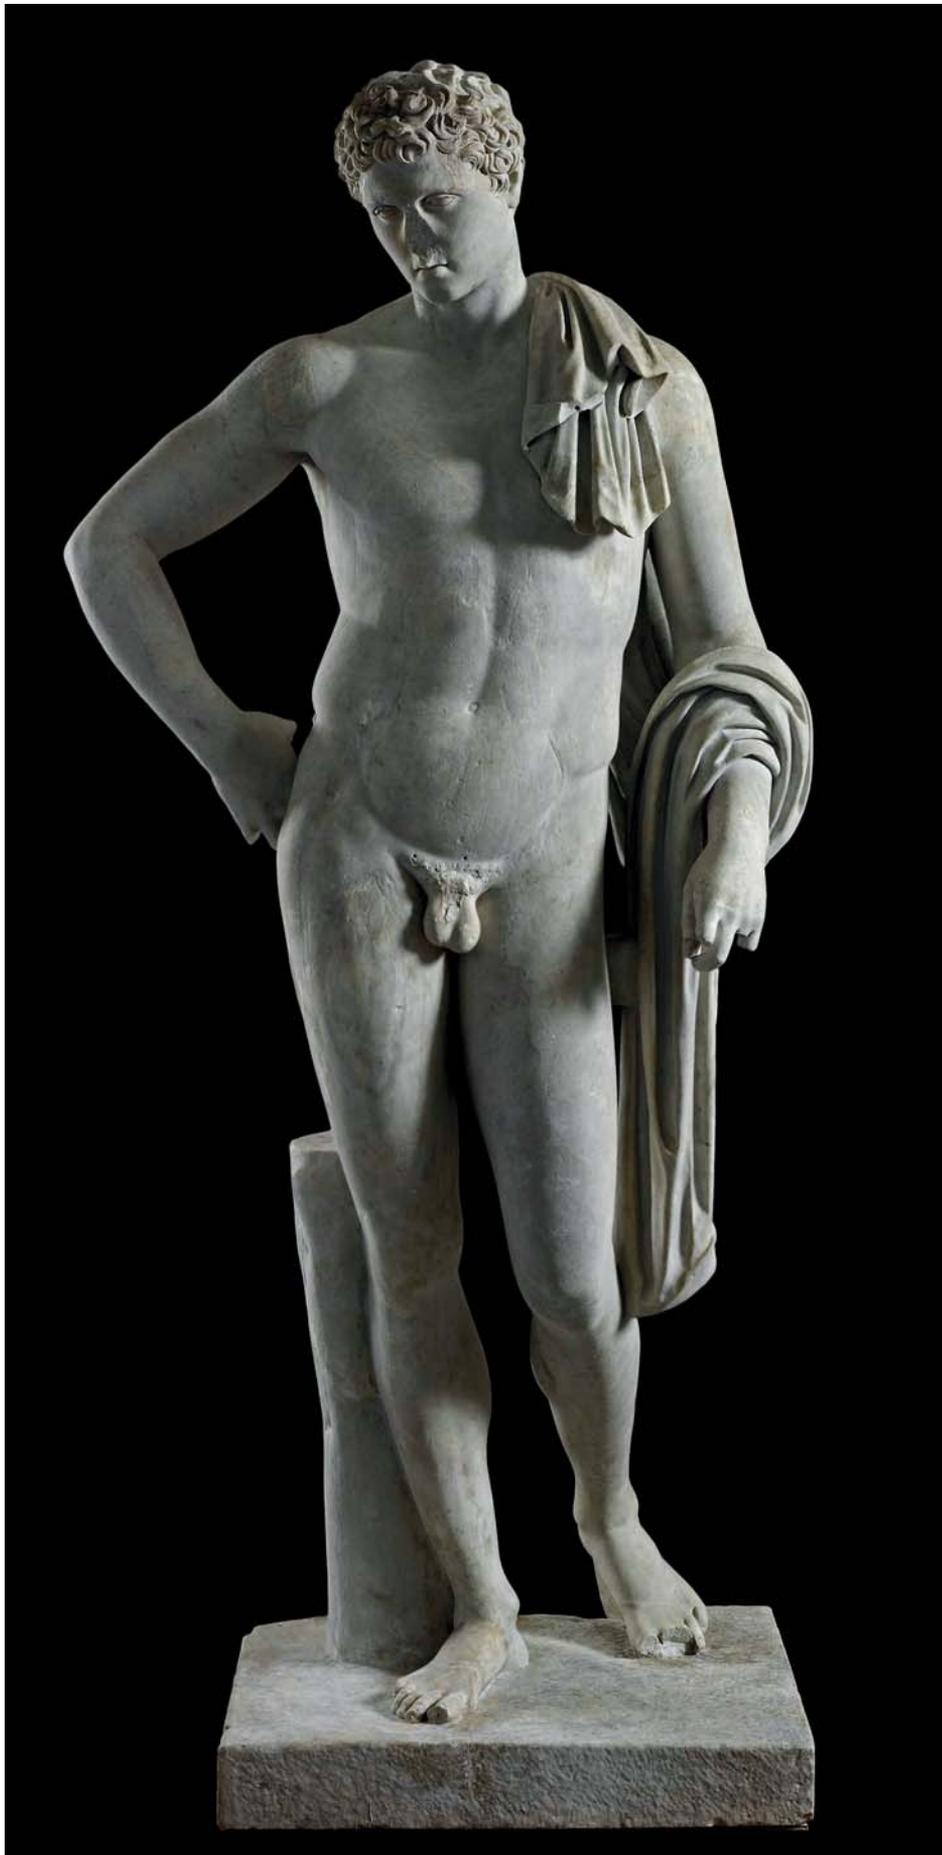
FIGURE 8. The Kew Garden Hermes after conservation

Now measuring a towering 2.1 m (Figure 8), the sculpture will once again be set up on its ancient altar base and go on display at the British Museum on long-term loan in a gallery that highlights the reception and development of Greek sculptural types in the Roman period.
